Root system assessment of helophytes

Resistance and root growth capacity in vegetated fiber rolls

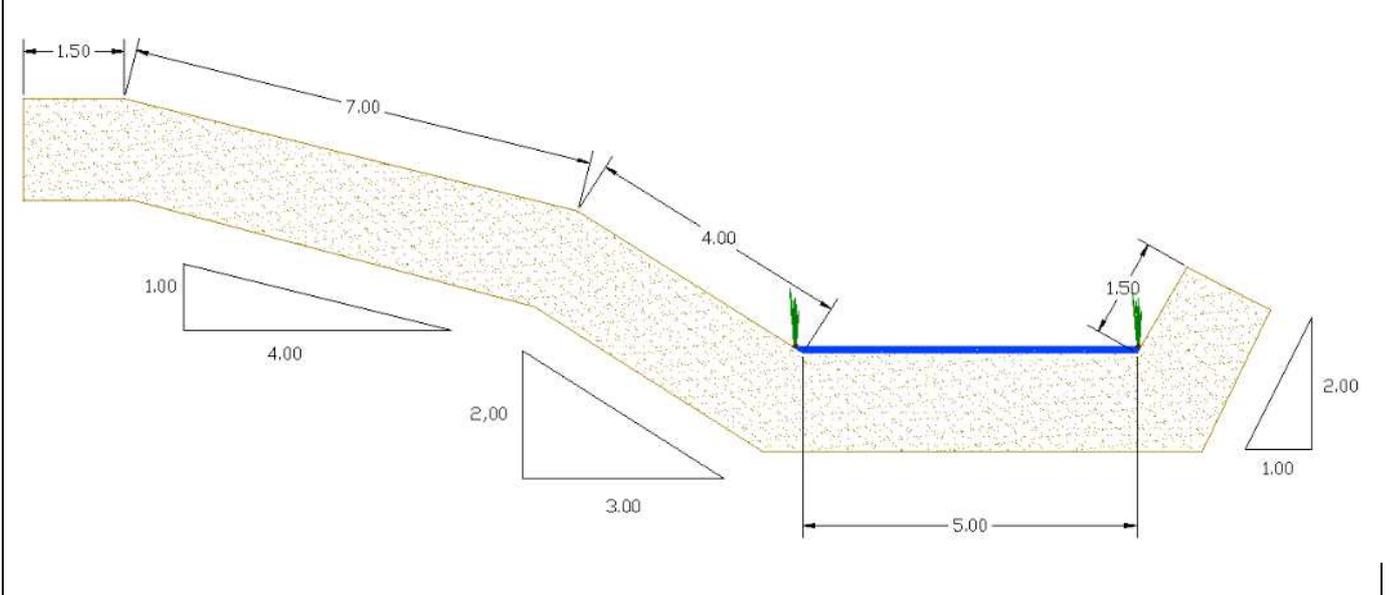
EVALUATION OF THE STATE OF FIBER ROLLS IN VALLMANYA AND REIXAC RIVERS

Evaluation of the material: No breaks or degradation are observed in the material, the structure and conditions are maintained.
Implementation evaluation: The fiber roll has not moved, is well attached to the soil with all the pegs and the bound working correctly.
Evaluation of the plantation: Current species are the same that were planted.
Comments: The initial percentage of species was the following: *Iris pseudacorus* 20%, *Carex pendula* 20%, *Scirpus holochoenus* 15%, *Carex vulpina* 15%, altres espècies 30%.
 At the moment this percentage has changed, with a predominance of *Iris pseudacorus* (70%), *Carex pendula* (12%) and *Carex vulpina* (13%) with the same abundance and *Scirpus holochoenus* in less abundance (5%).

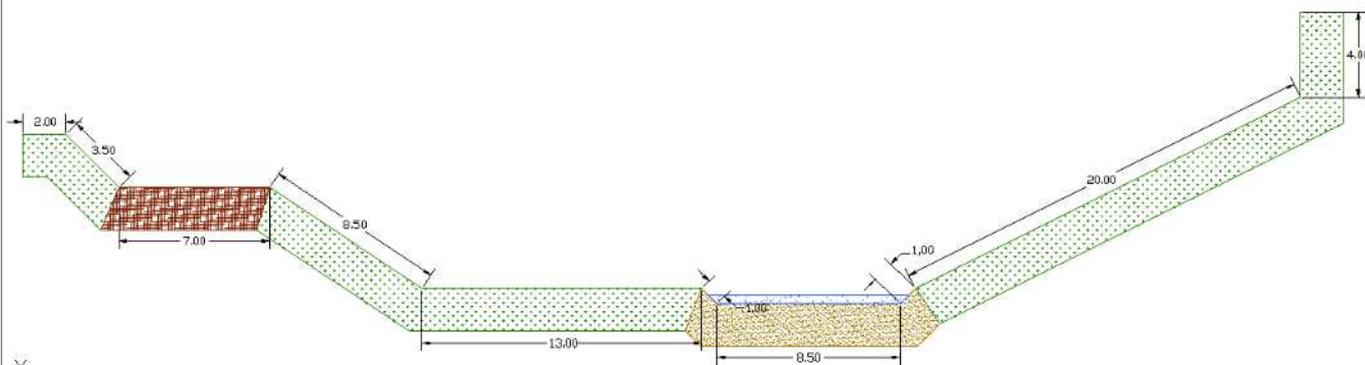
EVALUATION OF THE STATE OF FIBER ROLLS IN SANT ESTEVE SES ROVIRES RIVER

Comments: It was not possible to find the fiber roll. It was possibly located under the sand.

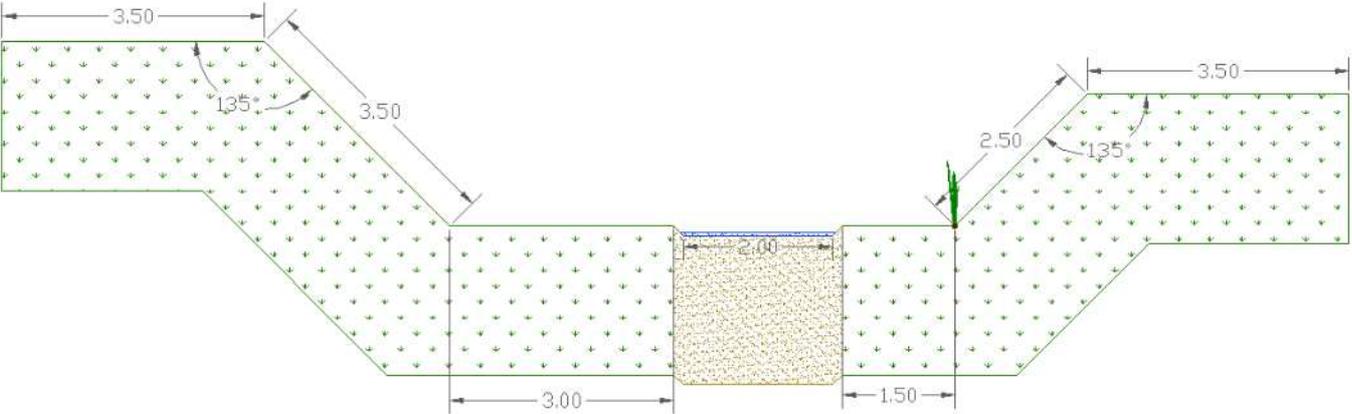
<p>4. EVALUATION</p>
<p>Evaluation of the material: No breaks or degradation are observed in the material, the structure and conditions are maintained. Still intact. Implementation evaluation: The fiber roll has not moved, is well attached to the soil with all the pegs and the bound working correctly, preventing the flow to pass through the front and the back of the fiber roll. Evaluation of the plantation: Current species are the same that were planted. Comments: Main presence of <i>Carex pendula</i>, <i>Scirpus holochoenus</i> and <i>Iris pseudacorus</i>.</p>

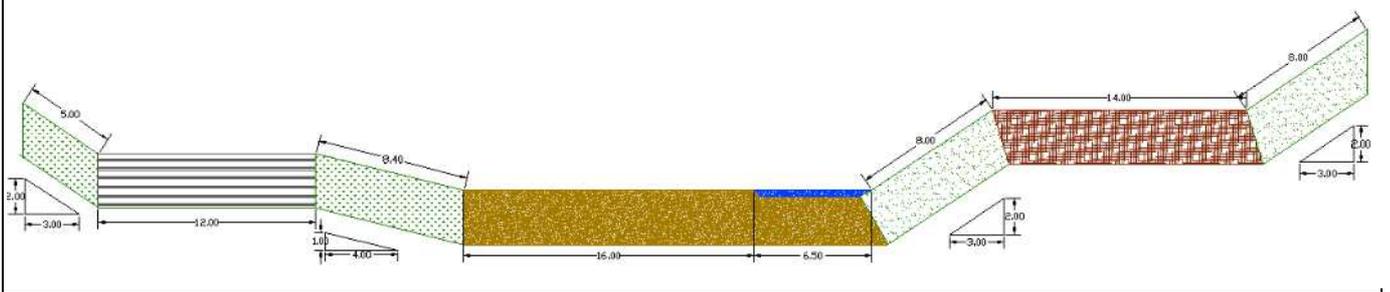
<p>4. EVALUATION</p>
<p>Evaluation of the material: No breaks or degradation are observed in the material, the structure and conditions are maintained.</p> <p>Implementation evaluation: The fiber roll has not moved, is well attached to the soil with all the pegs and the bound working correctly, preventing the flow to pass through the front and the back of the fiber roll.</p> <p>Evaluation of the plantation: Current species are the same that were planted, but there are no <i>Scirpus holochoenus</i> or <i>Carex vulpina</i> in the fiber roll, although no other species have colonized it.</p> <p>Comments: <i>Iris pseudacorus</i> occupies the entire fiber roll, there are no other species.</p>

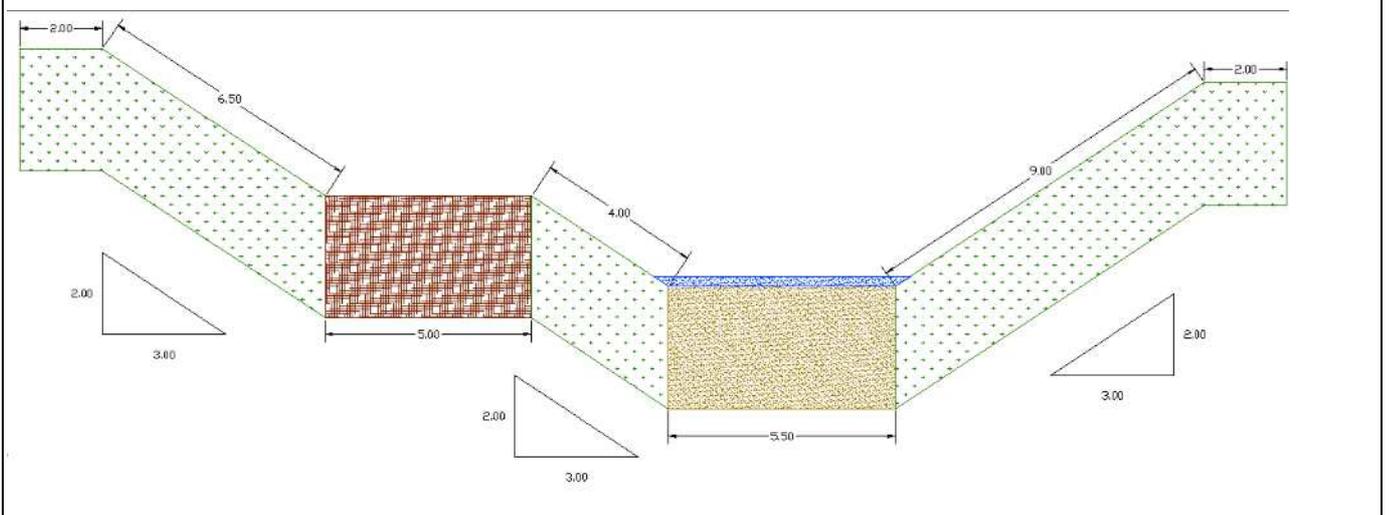
<p>4. EVALUATION</p>
<p>Evaluation of the material: No breaks or degradation are observed in the material, the structure and conditions are maintained.</p> <p>Implementation evaluation: The fiber roll has not moved, is well attached to the soil, the bound is in good conditions, preventing the flow to pass through the front and the back of the fiber roll. It is not possible to see the pegs because they are sunk.</p> <p>Evaluation of the plantation: Current species are not the same that were planted. <i>Iris pseudacorus</i> is absent in the fiber roll, although no other species have colonized it.</p> <p>Comments: The fiber roll is totally colonized by <i>Carex pendula</i>.</p>

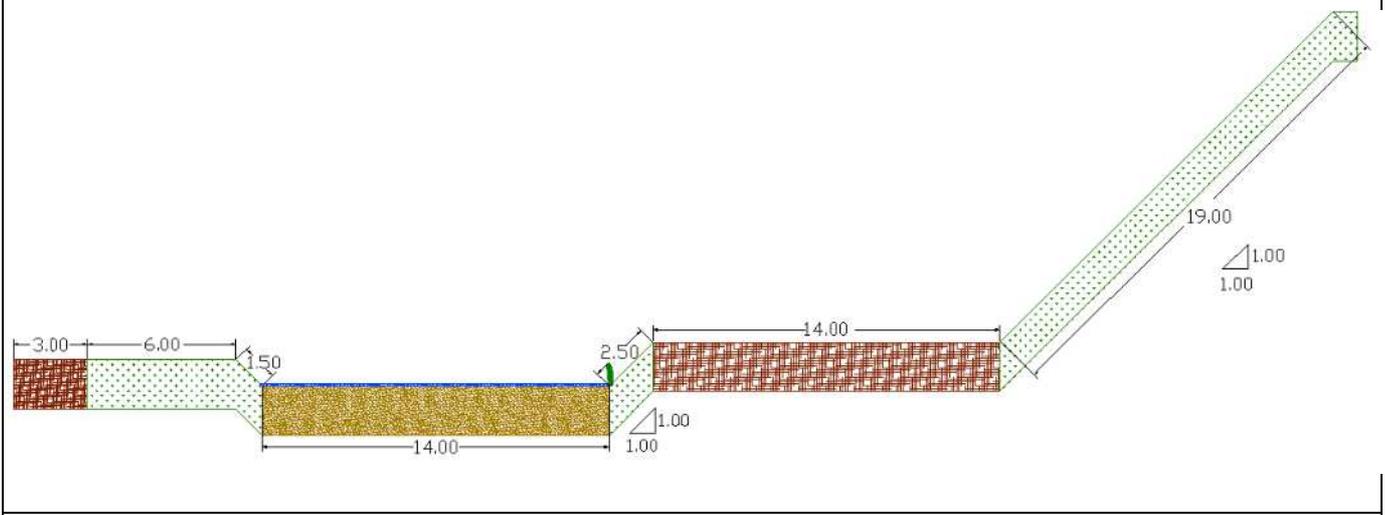
<p>The diagram illustrates the layout of fiber rolls. It starts with a 3.00m segment, followed by a 6.00m segment, a 1.50m transition, a 14.00m segment, a 2.50m transition, another 14.00m segment, and finally a 19.00m segment on a slope. Slopes are indicated as 1.00/1.00.</p>
<p>4. EVALUATION</p>
<p>Evaluation of the material: No breaks or degradation are observed in the material, the structure and conditions are maintained. Still intact. Implementation evaluation: The fiber roll has not moved, is well attached to the soil with all the pegs and the bound working correctly, preventing the flow to pass through the front and the back of the fiber roll. Evaluation of the plantation: Current species are the same that were planted (<i>Carex pendula</i>, <i>Iris pseudacorus</i>, <i>Carex vulpina</i>). There are no new species colonizing the fiber rolls. Comments: Main abundance of <i>Carex pendula</i> (50%) and <i>Iris pseudacorus</i> (40%) and less abundance of <i>Carex vulpina</i> (10%).</p>

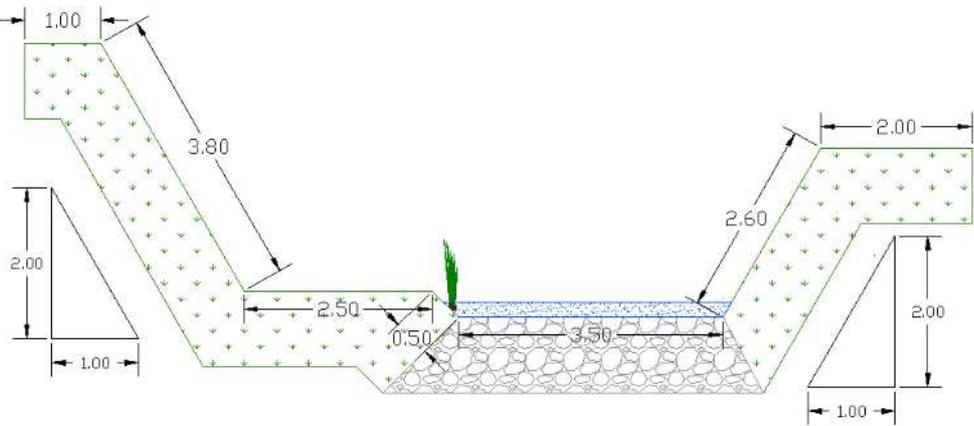
<p>4. EVALUATION</p>
<p>Evaluation of the material: No breaks or degradation are observed in the material, the structure and conditions are maintained.</p> <p>Implementation evaluation: The fiber roll has not moved, is well attached to the soil with all the pegs and the bound working correctly, preventing the flow to pass through the front and the back of the fiber roll.</p> <p>Evaluation of the plantation: Current species are the same that were planted, although there are some new species, which are not helophytes, in the fiber roll.</p> <p>Comments: The abundance of species in the fiber roll is: <i>Iris pseudacorus</i> 50%, <i>Scirpus holochoenus</i> 25%, <i>Carex pendula</i> 20% and <i>Carex vulpina</i> 5%.</p>
