Report of executed work

Restoration of the Vallicrosa stream at the section of Font del Pic in Sant Hilari Sacalm, Girona.

Project author and execution: Naturalea

Client: Sant Hilari Sacalm City Council

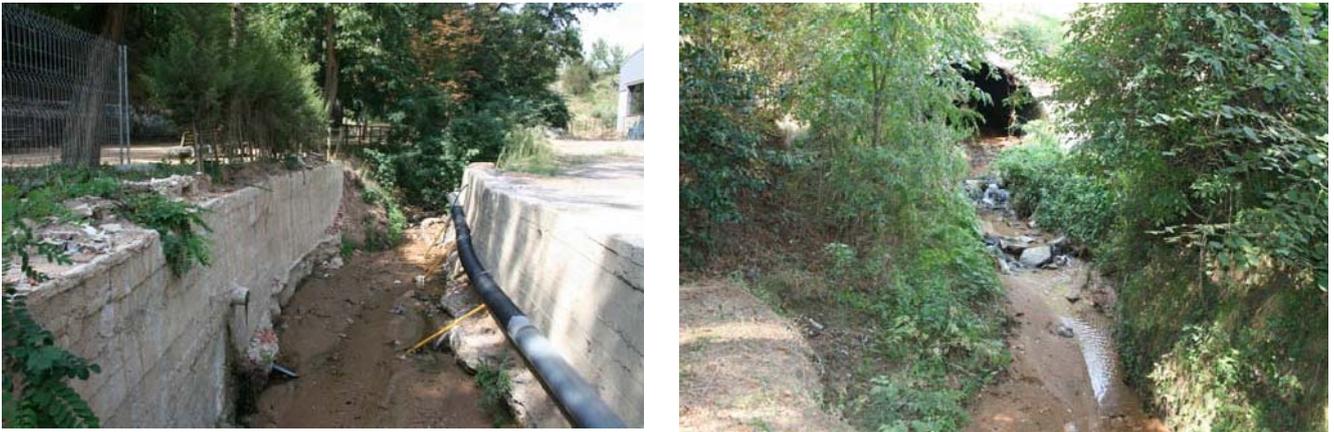
Image of the channel before the intervention

The structures were deconstructed and transported to a managed landfill. Next to the fountain, the action was carried two meters away from the current wall that connects with the slope. The wall was a result of a previous work by the City Council. The whole area around the stream was finally free of walls, foundations or any structure that was not original to the morphology of the stream.

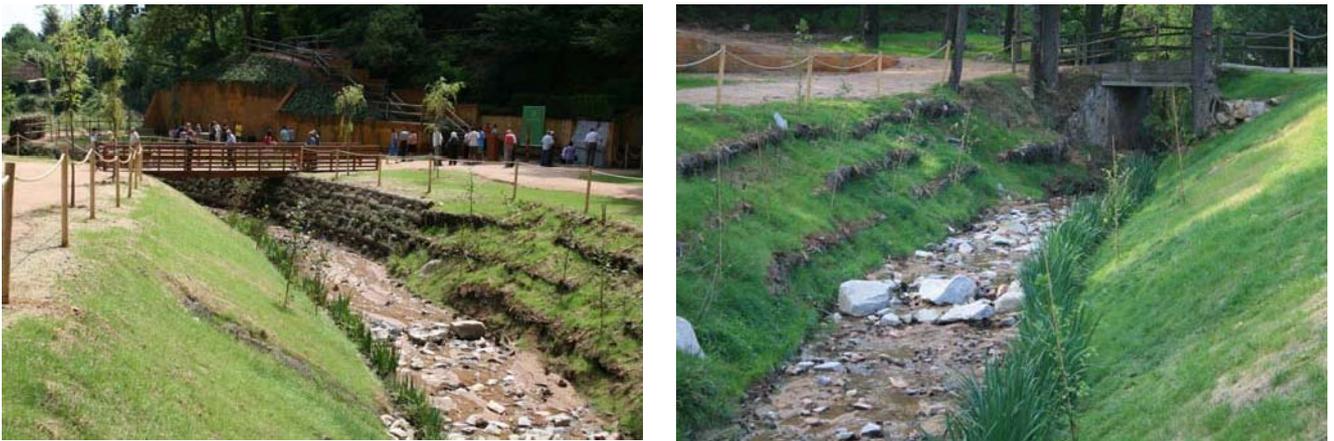
Image of the channel after the intervention

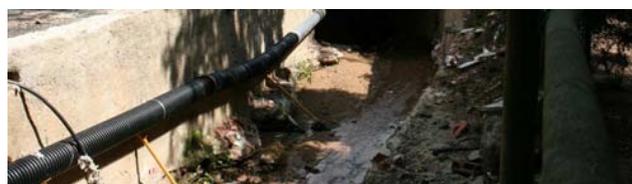
The collector is currently hanging from one of the walls along the river and must be moved behind its area of influence. This is a minor work, as the affected section is not very long, but it was essential to be able to carry out the previous action.

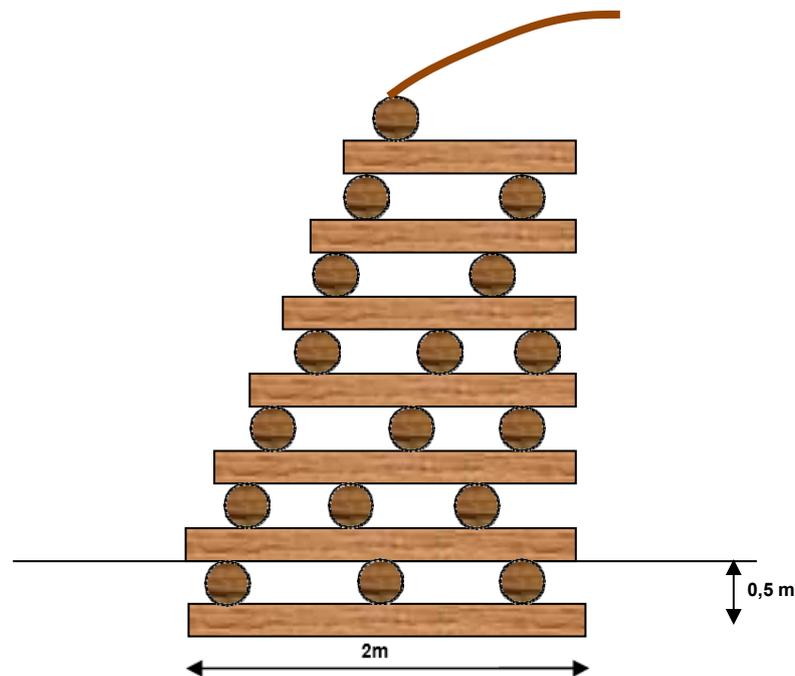
Scheme of the Krainer at the Vallicrosa stream

In order to stabilize and build river banks with a current speed greater than 4 m/s and susceptible to erosion, we proceed to the construction of a gravity wall formed by a cellular structure of wooden logs distributed in two walls, combined with the insertion of living plants. An area of 120 m² is occupied for the construction of the Krainer, with 12 levels in total (6 parallel and 6 perpendicular), 240 m.l. of live fascines and 1782 willow and alder stakes.

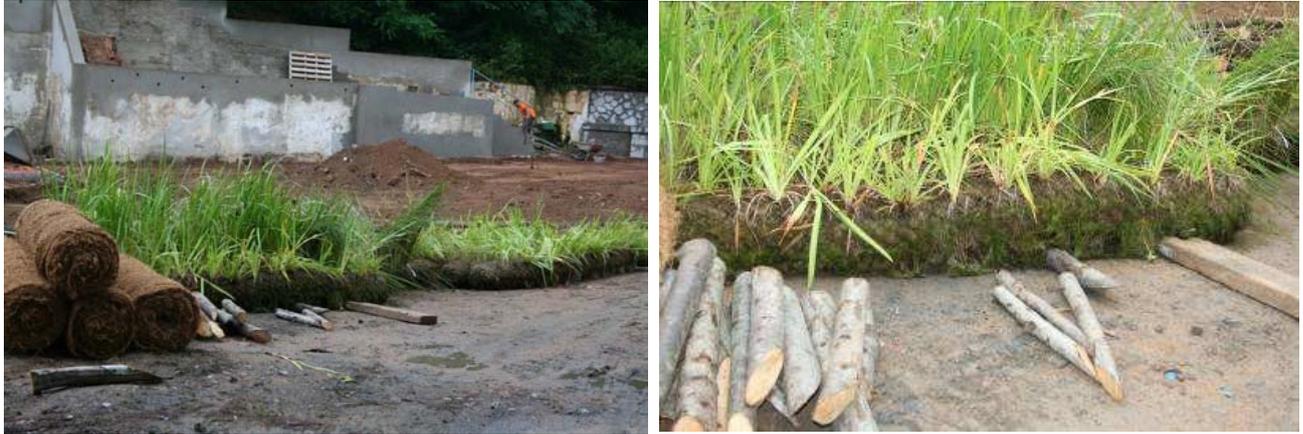
It is interesting to highlight the fact that, when folded, these species prevent the soil from erosion, having a protective function. A good example is the yellow lily (*Iris pseudacorus*) with very deep roots adapted to the presence of water; they can grow at the first front of the channel. This strategy is very good for flooding phenomena, and is insubstantial when excavators modify river channels. Consequently, these native species have disappeared from many of the current river systems.

The technical challenge is how to introduce these species so that they develop their resistance capabilities from the first minute after their installation. Another important factor is that the planting and restoration works do not harm the stability of the current systems. This problem is taken care of using bioengineering techniques, with a presentation of the plant inside a permanent coir fiber roll structure. Specifically, we propose for this implementation the vegetated Fiber roll to offer some structure to the base of the slope.

Afterwards, the slope was re-shaped and sowed with a mixture of native species from the Montseny area and then covered with a coir mesh. This technique gives structure to the slope for the next 3 or 4 years, until the vegetation is completely established.

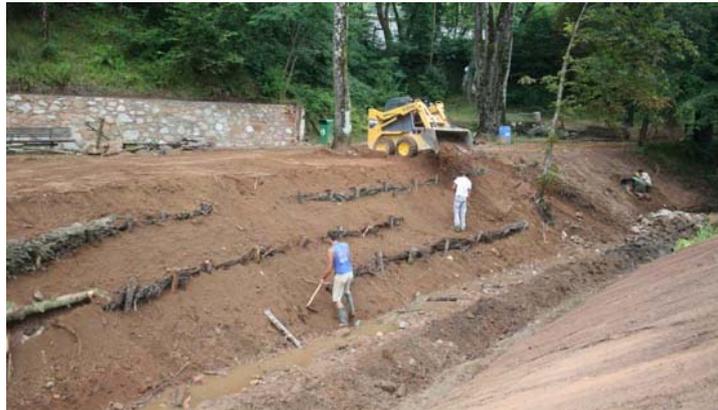
The community of the area consist in alder (*Alnetum catalaunicum*) and willow (*Saponario salicetum-purpureae*). The planted species (80) were the following: *Alnus glutinosa*, *Corylus avellana*, *Cornus sanguinea*, *Sambucus nigra*, and *Salix eleagnos*.

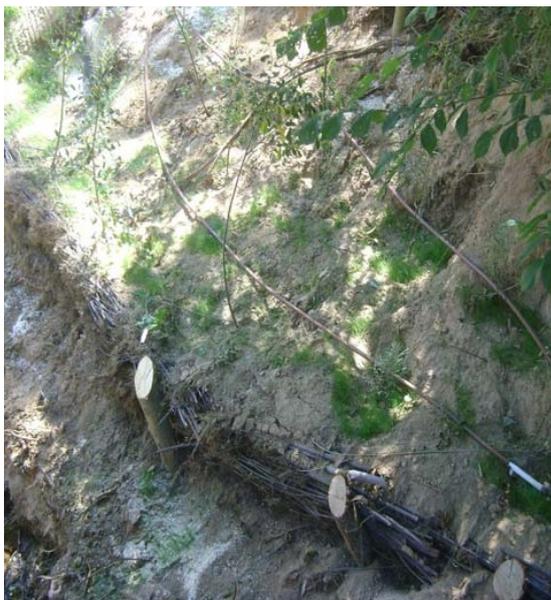
Fascines at the moment of installation

The more unstructured points of the slope were consolidated with dead-branch fascines, made with the material obtained from clearing the area. The aim was to improve the structure of the margin and as a supplement to the main action, the planting of the riparian forest.

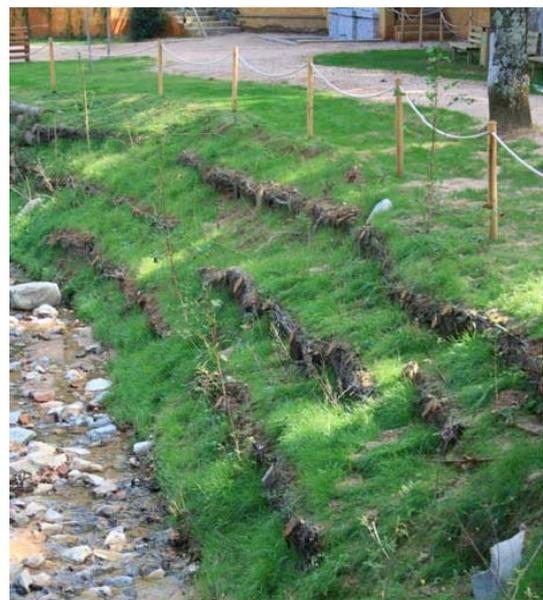
Fascines 6 months after the installation
